**Re: Ameren Missouri
Meramec Power Station
Dewberry & Davis, LLC Coal Combustion Waste Impoundment
Round 7 – Dam Assessment Report**

RE: Ash Pond Dam Stability Analysis
Meramec Power Station

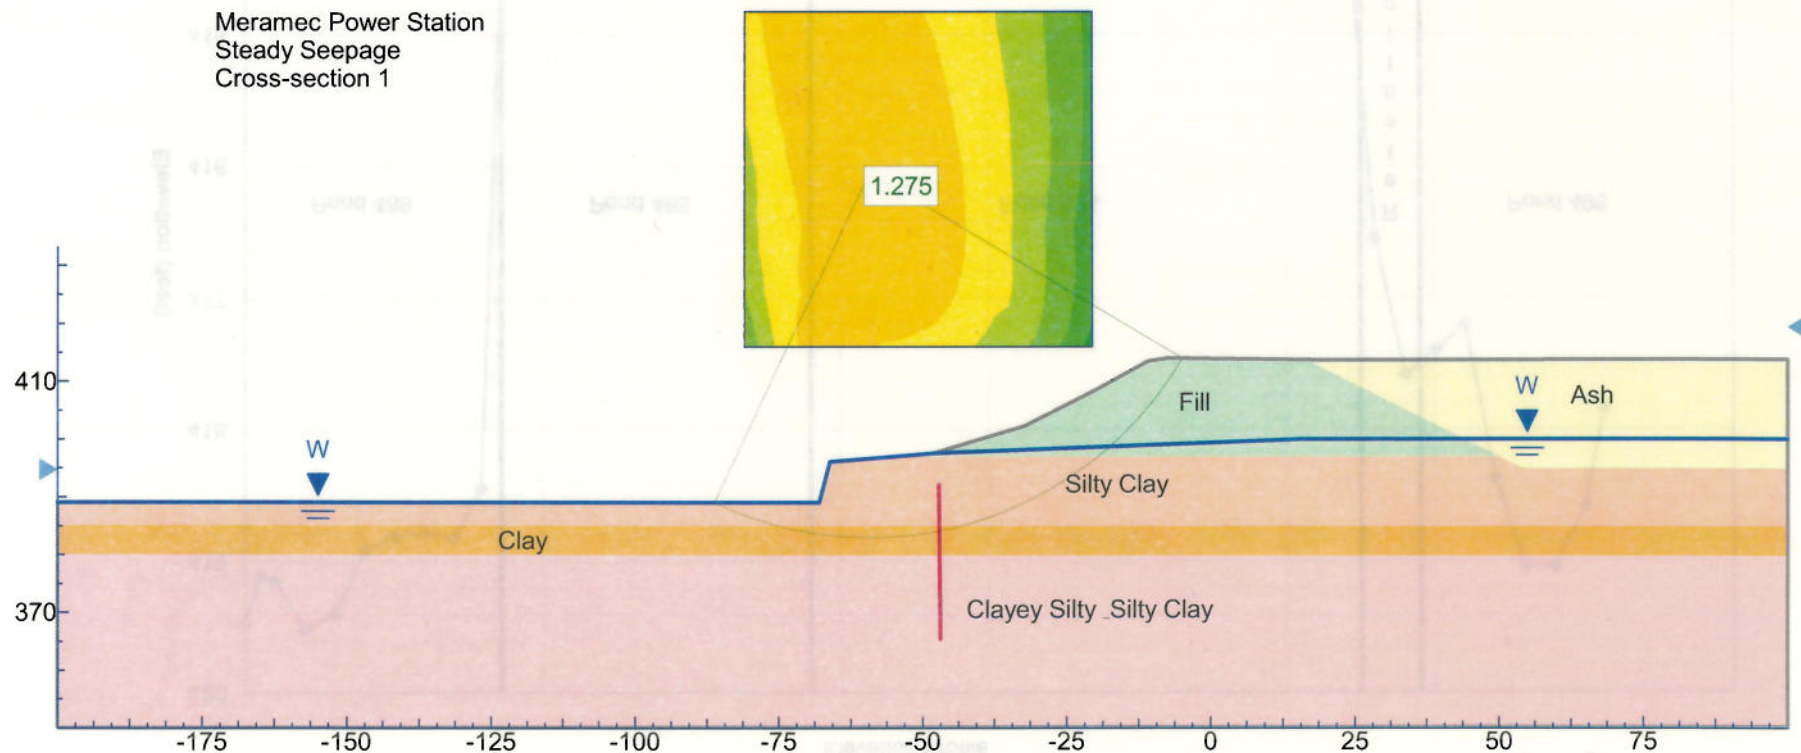
The analysis show for the steady seepage load case the calculated factor of safety is less than the required factor of safety by the MDNR. This analysis limited the search for critical failure surfaces to those that significantly impact the dam. The factor of safety is lower for shallow slope failures. For the seismic load case the factor of safety exceeded that required by the MDNR.

an environmental site class III dam, but for the steady seepage load case the factor of safety for all five cross-sections is below the minimum required. The low factor of safeties for the steady seepage case is primarily due to the steep downstream slope angles, which generally are steeper than 2 (H) on 1 (V). In addition, the upper most strata of the foundation soil generally consist of soft clay.

Material: Clayey Silt, Silty Clay
Unit Weight: 120 lb/ft³
Friction Angle: 25 degrees

Material: Silty Clay
Unit Weight: 123 lb/ft³
Cohesion: 100 psf
Friction Angle: 27 degrees

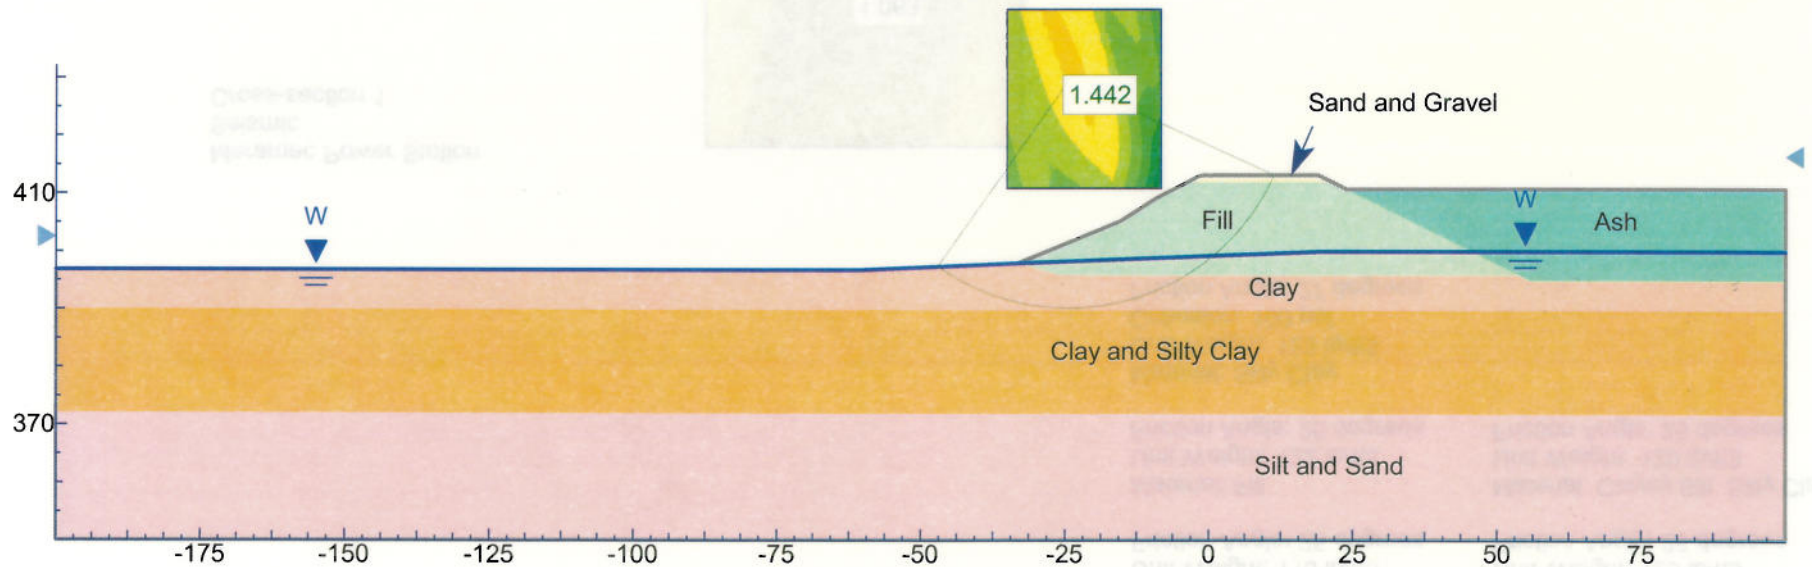
Meramec Power Station
Steady Seepage
Cross-section 2

Material: Silty Sand
Unit Weight: 120 lb/ft³
Friction Angle: 30 degrees

Material: Ash
Unit Weight: 110 lb/ft³
Friction Angle: 25 degrees

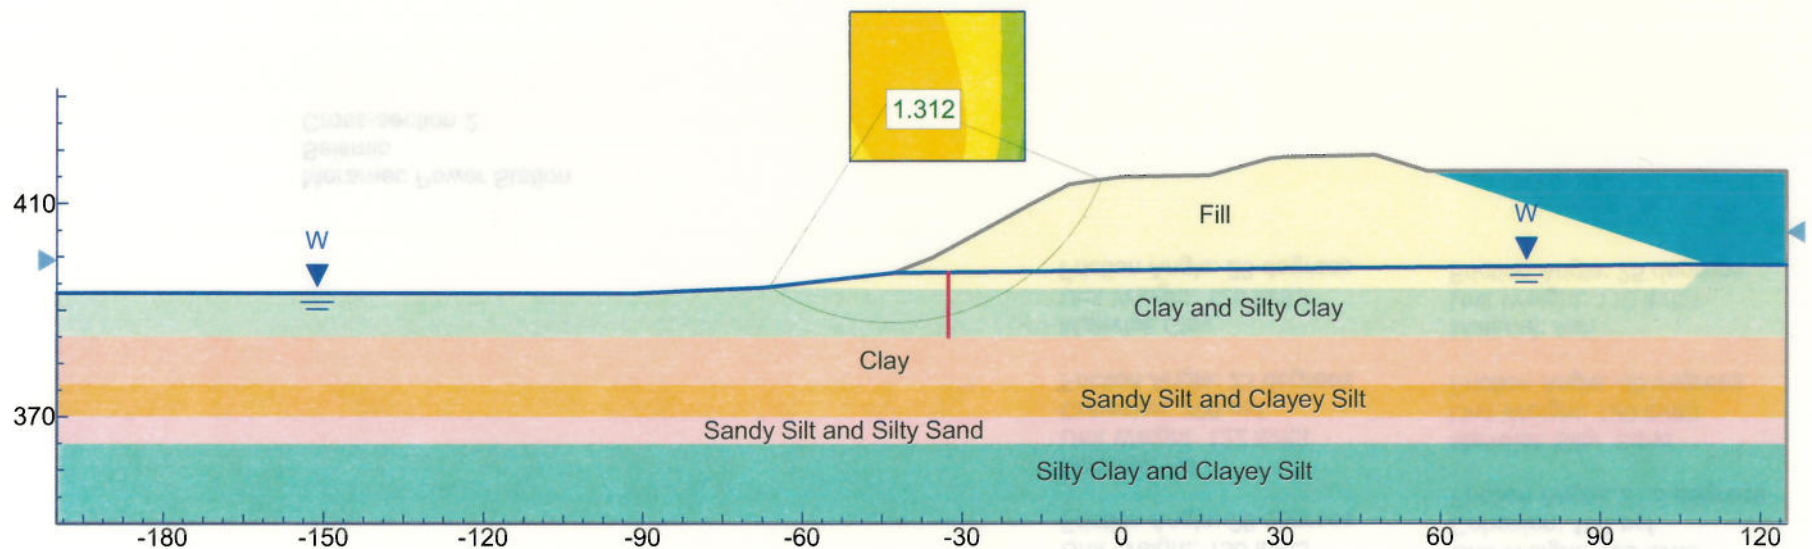
Meramec Power Station
Steady Seepage
Cross-section 3

Material: Silty Clay and Clayey Silt
Unit Weight: 120 lb/ft³
Friction Angle: 24 degrees
